**Redegørelse i anledning  
af tre havarier  
med Dash8 Q400**

**Bilag til redegørelsens kap. 6**

**Hæfte 2**

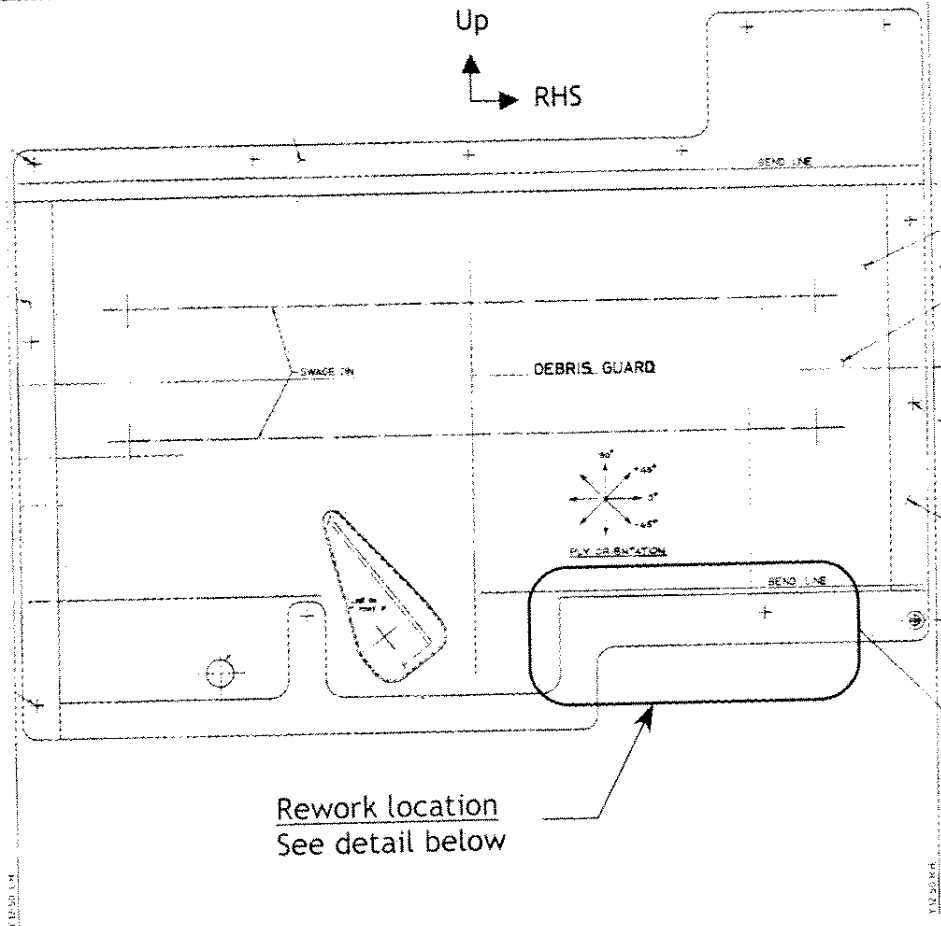
View looking fwd on debris guard showing location of rework

Re-protect reworked edges per the repair instructions.

Maintain original corner radius at this location (0.5" ref.)

Re-profile lower edge of debris guard to the maximum dimensions shown.  
Use .25" min. corner radii unless otherwise noted.  
Note: A smaller cutout may be used providing that it is sufficient to remove all of the chafe damage and alleviate any fouling condition.

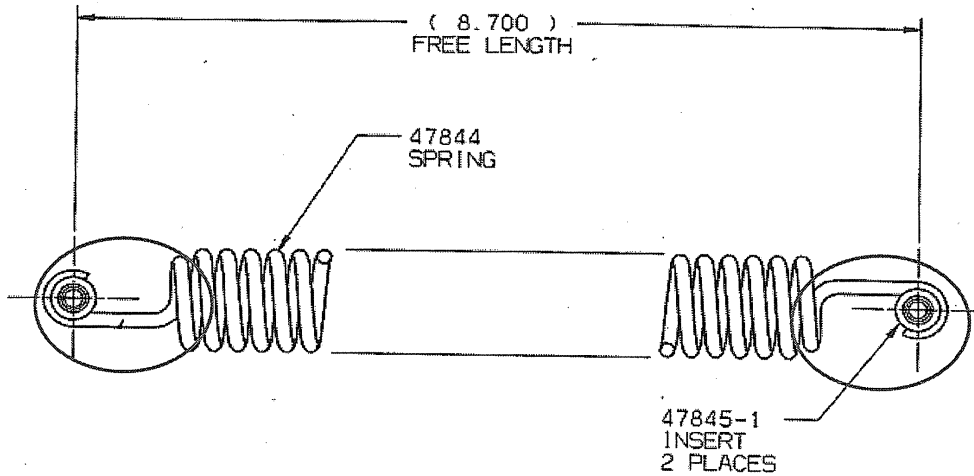
**FIGURE 1.**

ITEM	PROBLEM DESCRIPTION
1.	NLG FORWAD DOOR SPRING P/N 47844-1 MAY FAIL AND SEPARATE FROM MOUNTINGS PRESENTING A F.O.D ISSUE FOR THE NLG.  SEE SHEET 4 FOR LOCATION INFORMATION.
<b>REPORTED CAUSE OF PROBLEM:</b>	
<b>ADDITIONAL INFORMATION ATTACHED</b> <input checked="" type="checkbox"/>	
<b>SEE SHEET 2 AND SUBS FOR MORE INFORMATION</b>

CRITICAL AREAS FOR VISUAL INSPECTION AND LIQUID PENETRANT INSPECTION ARE HIGHLIGHTED ABOVE.

5. IF DAMAGE IS IDENTIFIED IN OPER #3, AND PART MEETS ACCEPTANCE CRITERIA OF OPER #4 (LPI), LIGHTLY POLISH AREAS SHOWING EVDIENCE OF SCRATCHES OR CHAFE DAMAGE AS REQUIRED TO JUST REMOVE ALL SHARP EDGES, NO POWER TOOLS PERMITTED.
  - DO NOT DEEPEN
  - MAX DEPTH OFDAMAGE NOT TO EXCEED .006 INCH.
  - IF MAX DEPTH EXCEEDED DISCARD PART.
6. ENGINEERING EVALUATION SHOWS ANY/ALL SPRINGS REWORKED IN ACCORDANCE WITH OPERATION 7, AND/OR HAVING LONGITUDINAL PLAY BETWEEN THE RETAINER AND SPRING ARE ACCEPTABLE FOR **250 A/C FC** OF CONTINUED SERVICE. WHEN FLIGHT CYCLE ALLOWANCE IS EXHAUSTED, DISCARD SPRING ASSEMBLY.
7. REASSEMBLE FWD DOOR LINKAGE WITH NEW OR SERVICABLE SPRING P/N 47844-1, AND RIG ACCORDING TO BOMBARDIER AMM PROCEDURES.
8. PERFORM ANY/ALL RETURN TO SERVICE ACTIONS IN ACCORDANCE WITH BOMBARDIER AMM.

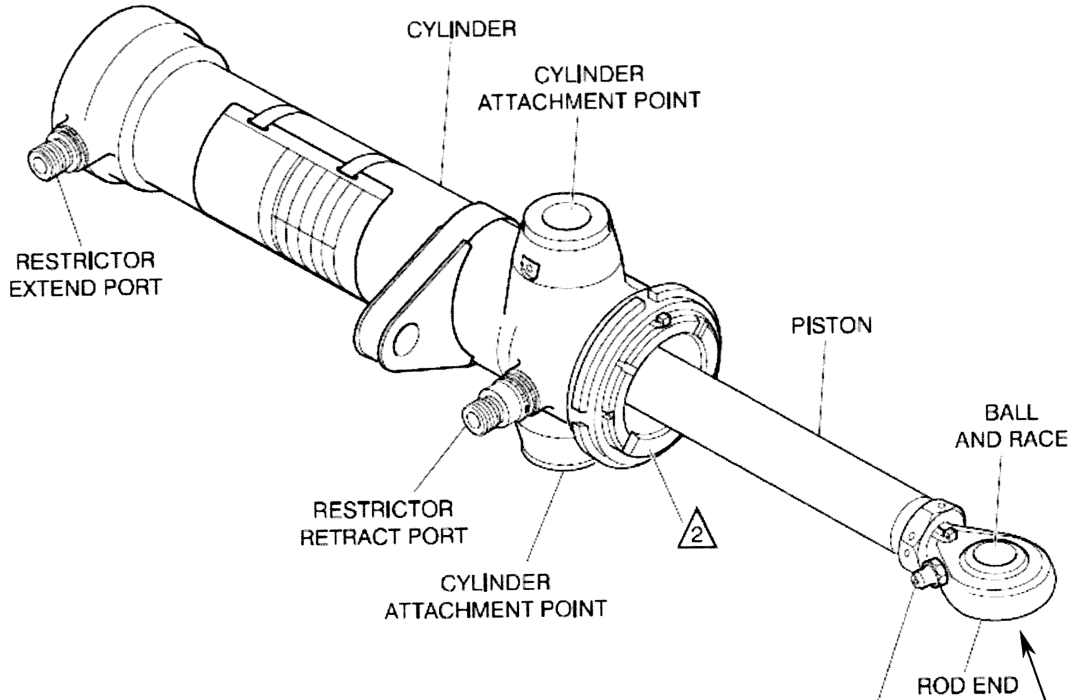
## Retraction actuator assembly p/n 46550-7/-9

Inspect affected parts for any signs of corrosion or wear.

Remove the rod end of the retraction actuator assembly in accordance with SCR 086-07 rev. D

Provided the components are free of any damage re-assemble retraction actuator in accordance with SCR 086-07 rev. D

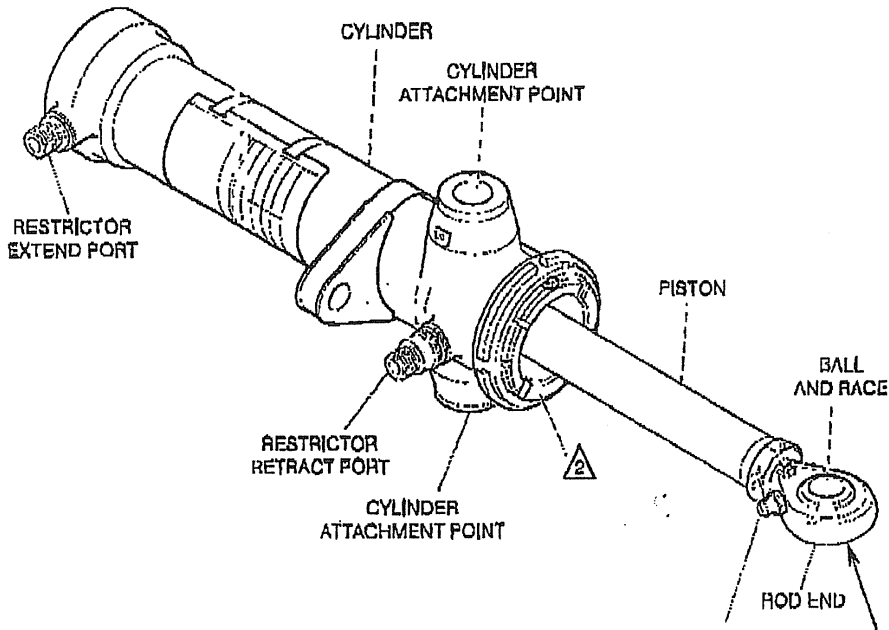
Retraction actuator assembly p/n 46550-7/9

Inspect affected parts for any signs of corrosion or wear.

No corrosion or wear damage is allowed, *EXCEPT AS NOTED IN SCR 086-07 REV. ~~A~~ ~~B~~ C*

Remove the rod end of the retraction actuator assembly in accordance with SCR 086-07 rev. ~~A~~ ~~B~~ **C**

Provided the components are free of any damage re-assemble retraction actuator in accordance with SCR 086-07 rev. ~~A~~ ~~B~~ **C**

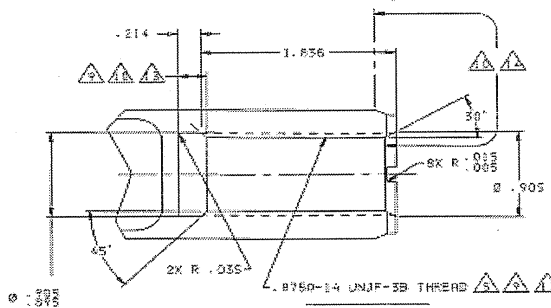
**FIGURE 1**

10. VISUALLY INSPECT PISTON (P/N 46570-1/-3) THREADS AND THREAD RELIEF AREA FOR EVIDENCE OF CORROSION AND/OR DAMAGE AND/OR PITTING (REF. FIGURE 1), USING 10X MAGNIFICATION MIRROR OR BORESCOPE UNDER ADEQUATE LIGHTING CONDITIONS.
  - IF CORROSION IS FOUND IN THREADED AREA OF PISTON P/N 46570-1/-3 PERFORM REWORK IN ACCORDANCE WITH **SECTION B** OF THIS SCR
  - IF NO CORROSION IS FOUND CONTINUE WITH REMAINING OPERATIONS

3. INSPECT THE ENTIRE PROFILE OF THREADS OVER THE FULL SPAN OF THREADS (REF. 1.836 DIM, FIGURE 1) AND THE RELIEF GROOVE IN PISTON USING 10X MAGNIFICATION MIRROR OR BORESCOPE UNDER ADEQUATE LIGHTING CONDITIONS.

1. MASK AS REQUIRED TO PROTECT ACTUATOR HOUSING, GLAND AREA, AND EXPOSED CHROME OF PISTON FROM F.O.D CONTAMINATION AND DAMAGE DURING THE FOLLOWING REWORK.

2. CHASE PISTON THREADS AND THREAD RELIEF AREA TO REMOVE CORROSION PRODUCTS TO THE GREATEST POSSIBLE EXTENT USING THREAD COMB AND/OR STAINLESS STEEL WIRE BRUSH.

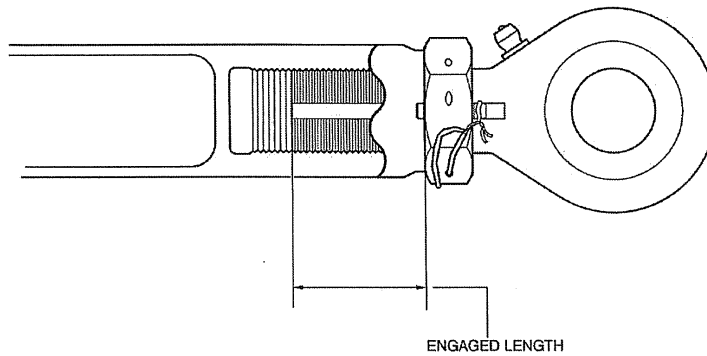
**FIGURE 2**

4. **ACCEPTANCE CRITERIA/REWORK OPTIONS**
  - A) LIGHT SURFACE CORROSION (NO PITTING) OVER THE ENTIRE THREADED LENGTH WITH AT LEAST FIVE CONSECUTIVE FULL UNDAMAGED THREADS WITHIN THE ENGAGED THREAD LENGTH (REF FIGURE 2) IS ACCEPTABLE FOR **1000 FC OR 6 MONTHS** (WHICH EVER OCCURS FIRST) OF CONTINUED SERVICE. THE RETRACT ACTUATOR IS TO BE INSPECTED TO ENSURE JAM NUT IS SECURE AND WIRE LOCK IS IN PLACE EVERY **100 FC**

B) EVIDENCE OF MODERATE PITTING CORROSION CAN BE REWORKED: (REF FIG 2)

- a. TO DWG S2116 (HELICOIL SOLUTION). HELICOIL REWORK IS ACCEPTABLE FOR **1000 FC OR 6 MONTHS** (WHICH EVER OCCURS FIRST) OF CONTINUED SERVICE.
- b. TO DWG S2117 (DOWEL PIN SOLUTION) PROVIDED THAT AN ESTIMATED HALF OF THE ENGAGED THREAD VOLUME (I.E. AT LEAST THE EQUIVALENT OF 7 THREADS) REMAIN. DOWEL PIN REWORK IS ACCEPTABLE FOR **500 FC OR 3 MONTHS** (WHICH EVER OCCURS FIRST) OF CONTINUED SERVICE. **DAILY VISUAL INSPECTION** OF PIN TO ENSURE RETENTION AND ACTUATOR EXTERNAL LEAKAGE IS ALSO REQUIRED
- c. REPLACED

FOR OPTIONS a) AND b), THE RETRACT ACTUATOR IS TO BE INSPECTED TO ENSURE JAM NUT IS SECURE AND WIRE LOCK IS IN PLACE EVERY **100 FC**.

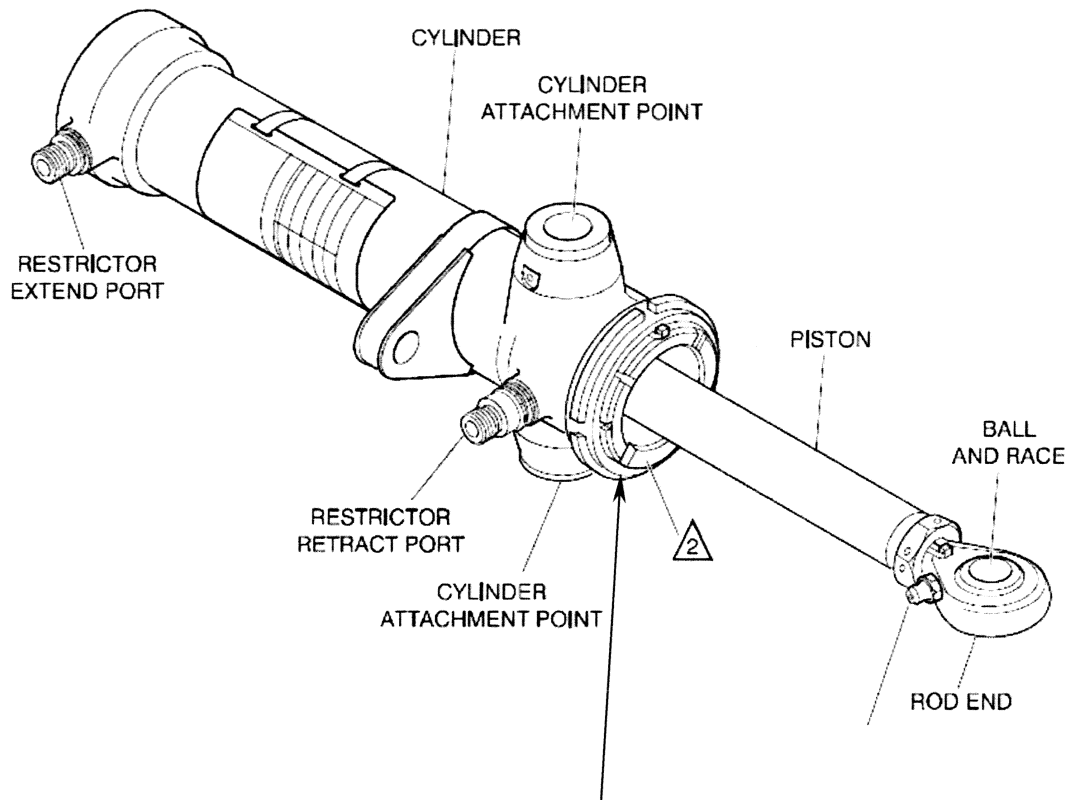
## Retraction actuator assembly p/n 46550-7/-9

Inspect cylinder P/N 4655-1 for evidence of corrosion on Gland Nut threads.

Inspect Gland Nut P/N 46572-5 for evidence of corrosion on threads.

Remove the rod end of the retraction actuator assembly in accordance with SCR 091-07 rev. NC

Provided the components are free of any damage/corrosion, re-assemble retraction actuator in accordance with SCR 091-07 rev. NC

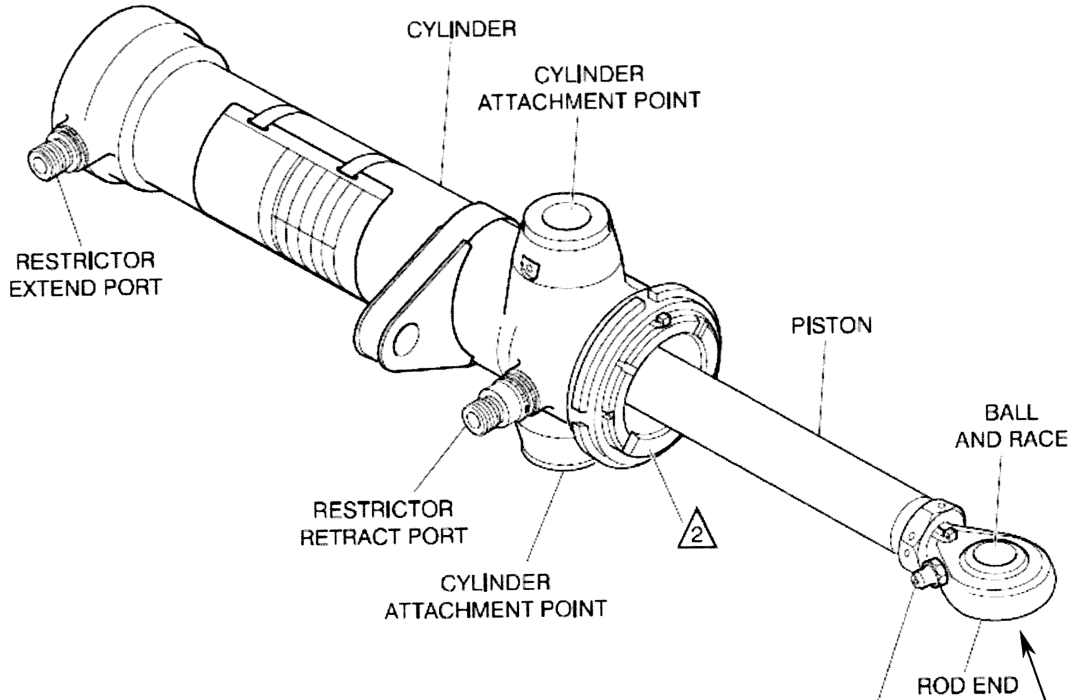
## Retraction actuator assembly p/n 46550-7/-9

Inspect affected parts for any signs of corrosion or wear.

Remove the rod end of the retraction actuator assembly in accordance with SCR 086-07 rev. D

Provided the components are free of any damage re-assemble retraction actuator in accordance with SCR 086-07 rev. D

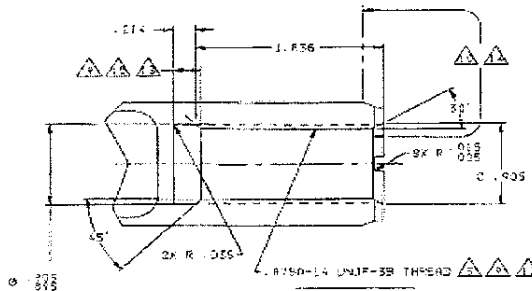
**FIGURE 1**

- IF CORROSION IS FOUND IN THREADED AREA OF PISTON P/N 46570-1/-3 PERFORM REWORK IN ACCORDANCE WITH **SECTION B** OF THIS SCR
  - IF NO CORROSION IS FOUND CONTINUE WITH REMAINING OPERATIONS

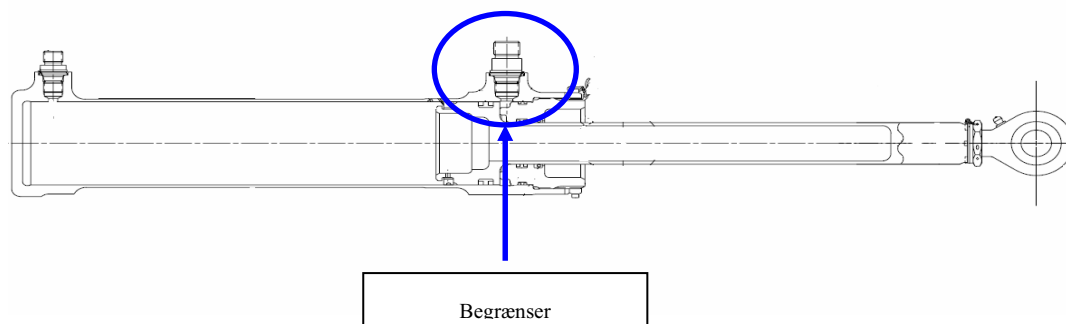
Nedenstående figur viser højre understels aktuator (retraction/extension actuator assembly) og placeringen af den blokerede begrænser.

Begrænseren (retraction/extension actuator restrictor valve) var blokeret af en O-ring. O-ringen kom ikke fra aktuatoren, og dens oprindelse er indtil videre ukendt.

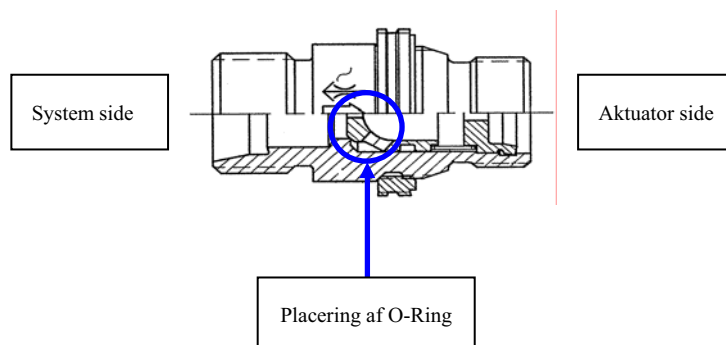
Nedenstående figur viser begrænseren (retraction/extension actuator restrictor valve) og den position, hvor O-ringen som blokerede begrænseren blev lokaliseret.

Den utilsigtede tilstedeværelse af O-ringen og de deraf afledte konsekvenser, vurderes på det foreliggende grundlag til kun at berøre dette luftfartøj.

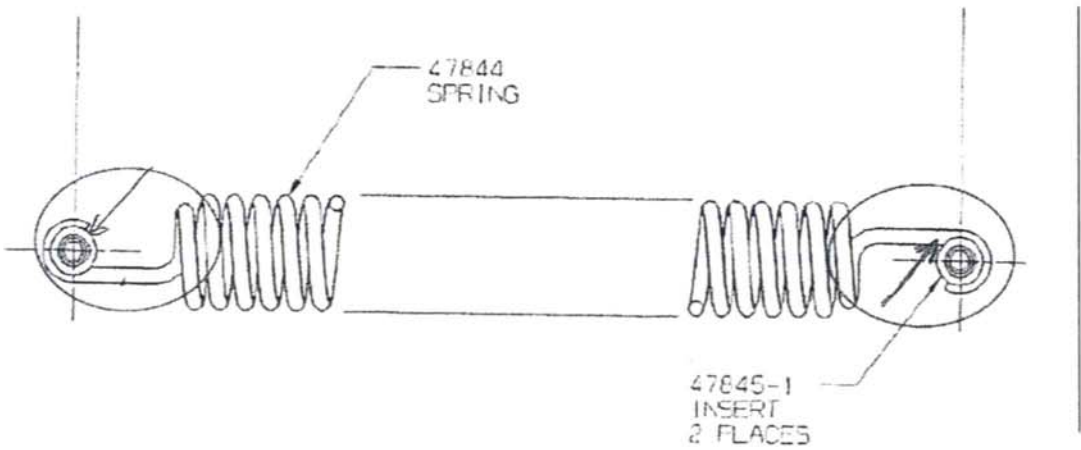
Report findings and illustrate:  
FOUND SHAFING ON RETAIN SPRING  
AROUND RETAINER  
NO Findings FPI
